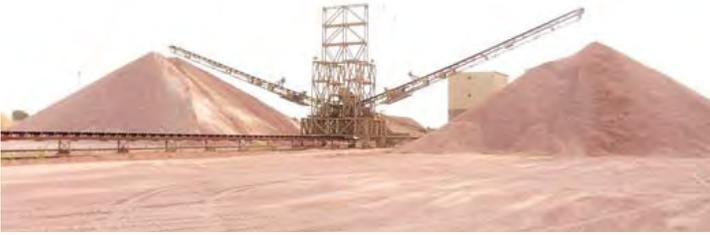
A5 - Yes, because there is a picture of a quarry, where off site fill materials would originate from, therefore they are being used on site

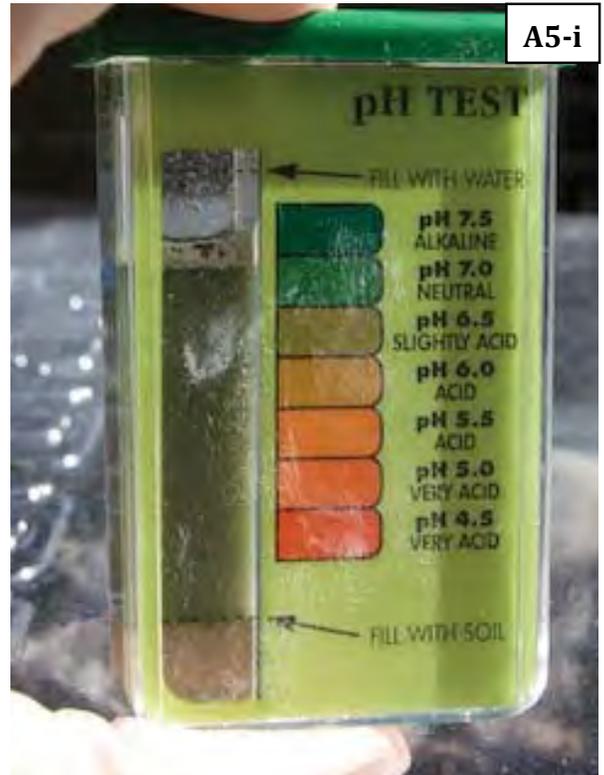
A5-i - Yes, because in the picture a pH test is being done on the off site fill material, therefore it was inspected

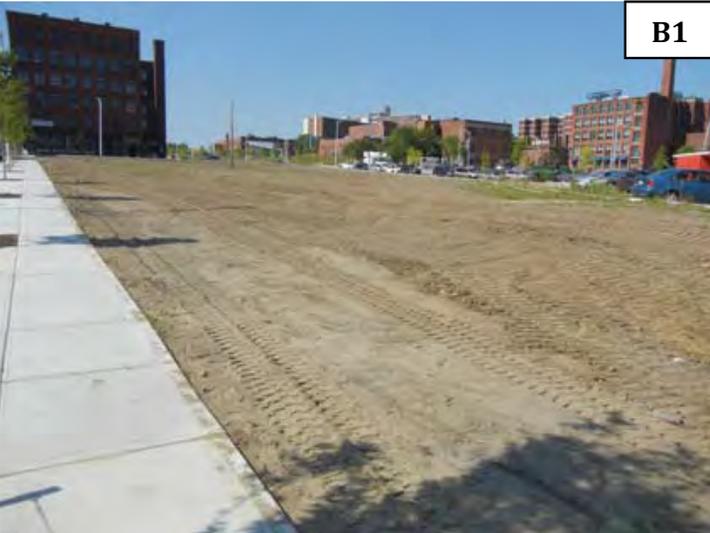
B1 - No, because in the picture there are no erosion controls in place and construction has clearly started, therefore erosion controls were not put in place before initiating soil disturbance activities

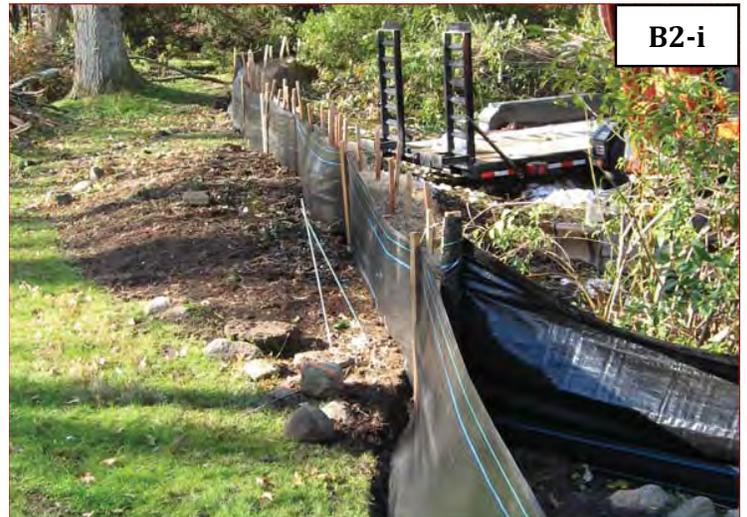
B2-i - Yes, because in the picture there is a silt fence being used as an LOD, which is in place to protect nearby environmental resources

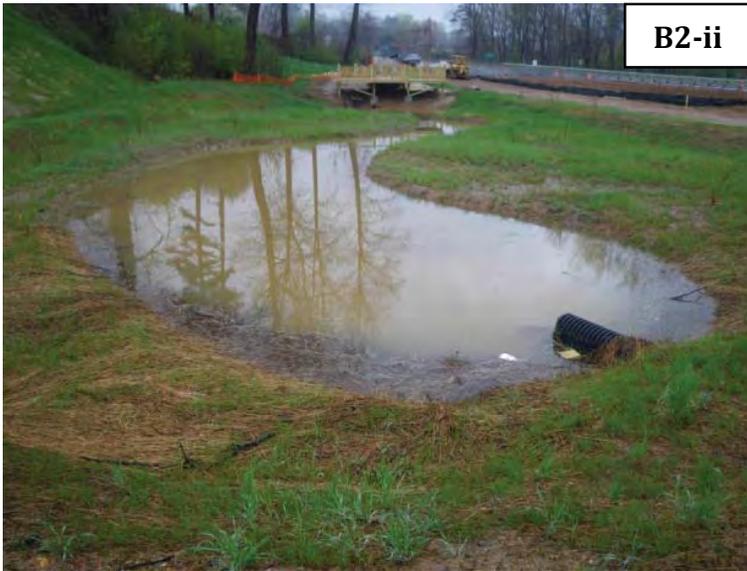
B2-ii - No, because in the picture there is an existing infiltration area on a construction site that has not been protected by an LOD

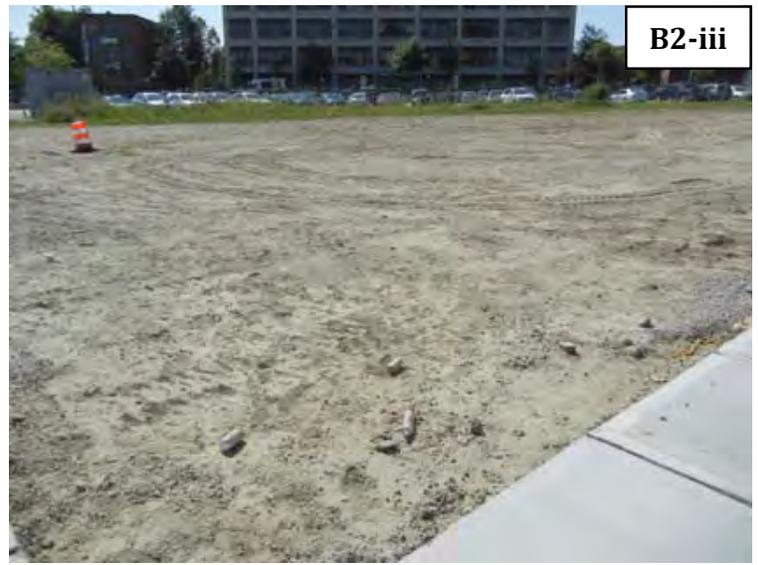
B2-iii - No, because in the picture there are no LOD marked on site, therefore they are not in compliance with having the LOD be consistent with the approved site plans

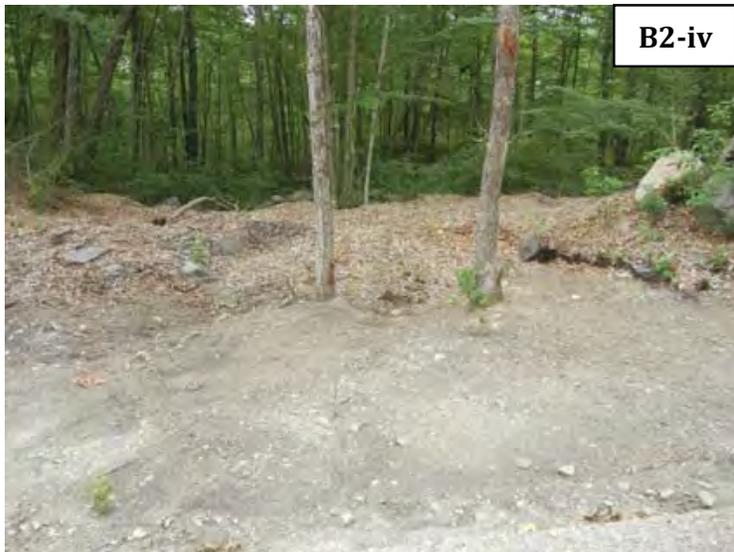
B2-iv - No, because in the picture there is a pile of mulch dumped in the wooded area, which is beyond the approved LOD

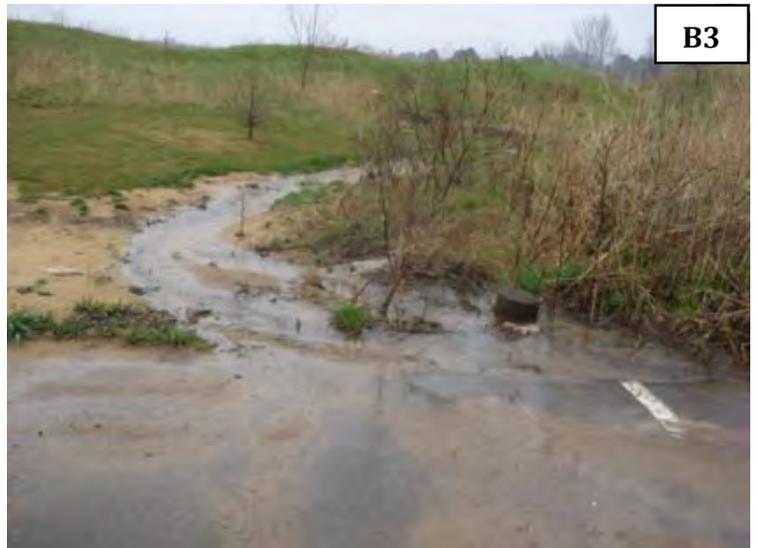
B3 - No, because in the picture there are no controls in place to limit the runoff of exposed soils, the stormwater flow is full of sediment and not being properly contained on site

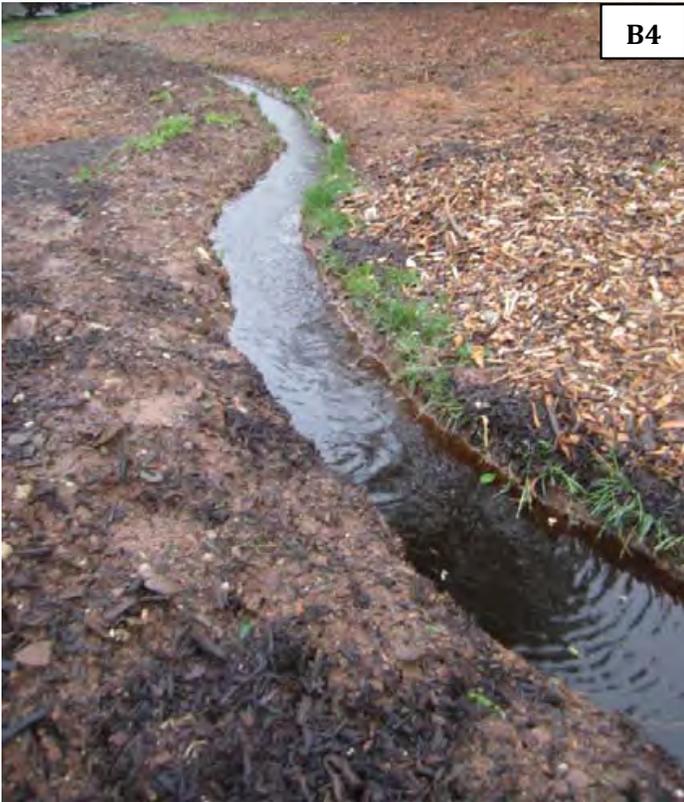
B4 - Yes, because in the picture there is a nicely designed temporary water conveyance, which was designed correctly and is currently functioning properly

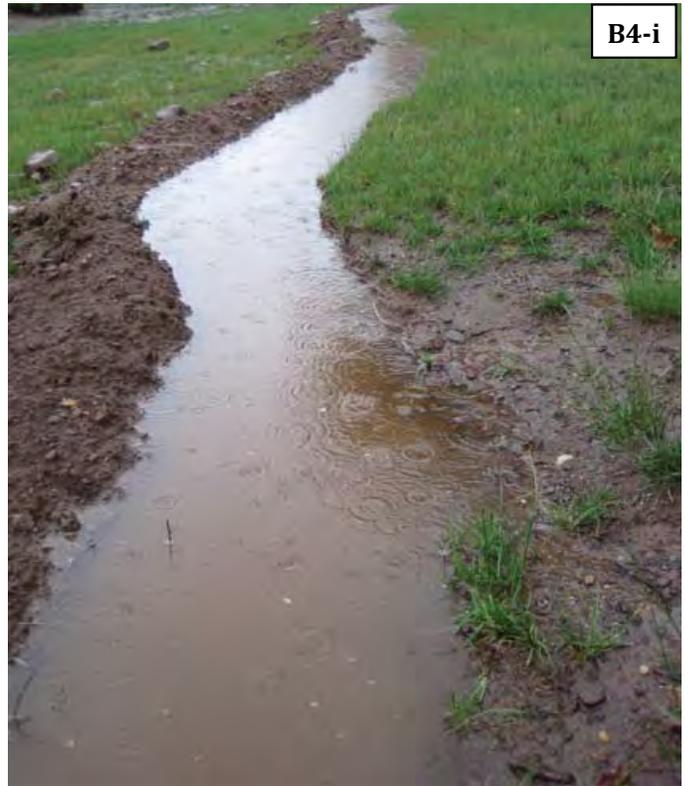
B4-i - No, because in the picture the once properly functioning temporary water conveyance has become riddled with sediment/ unstabilized and needs to be properly maintained

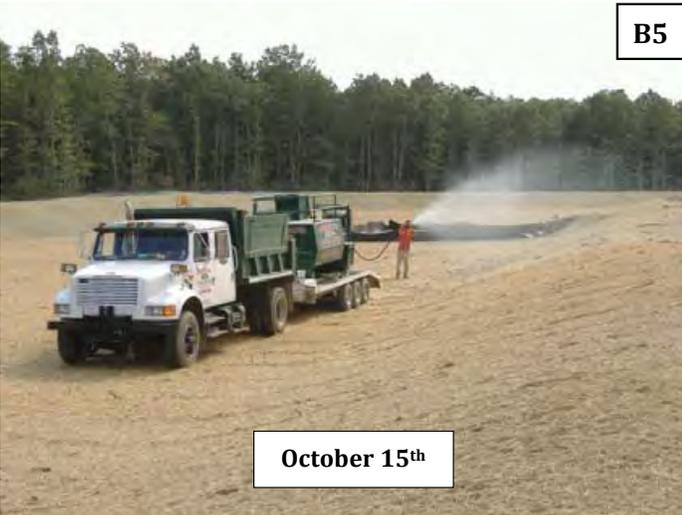
B5 - Yes, because in the picture they are seeding curenly unstabilized areas on October 15th

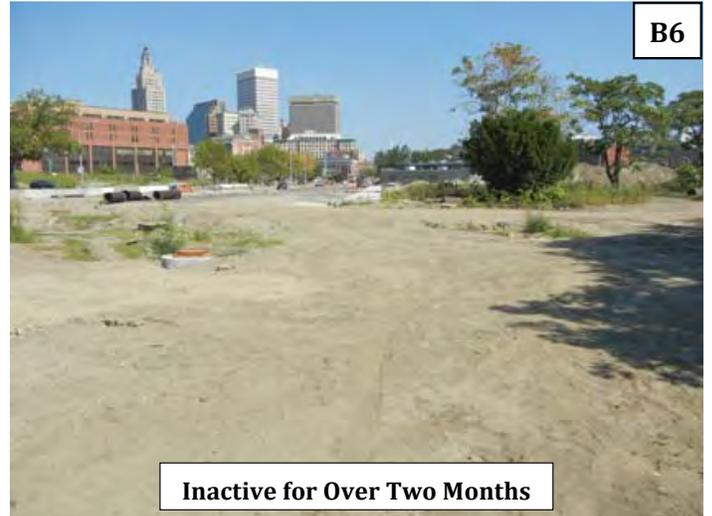
B6 - No, because in the picture there is a large area of the site which has been inactive for over two months and has not been properly stabilized after exceeding 14 days of inactivity as required

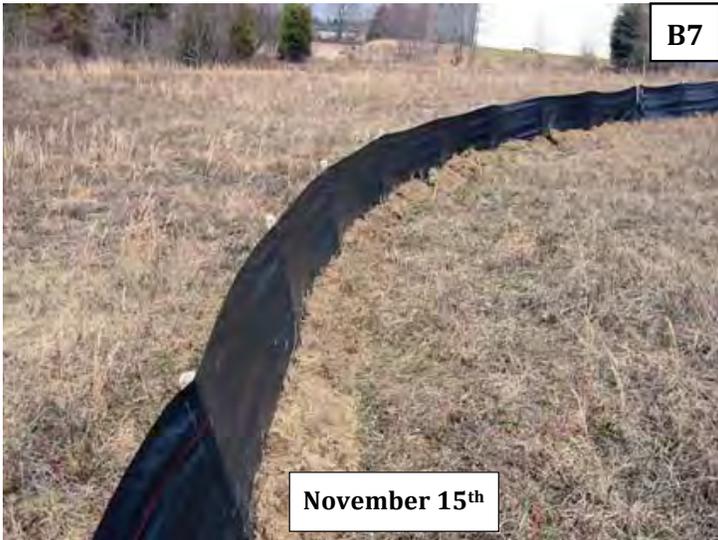
B7 - Yes, because in the picture a suitable growth of vegetation has not yet been reached by November 15th, so erosion controls have been implemented here to effectively stabilize the site

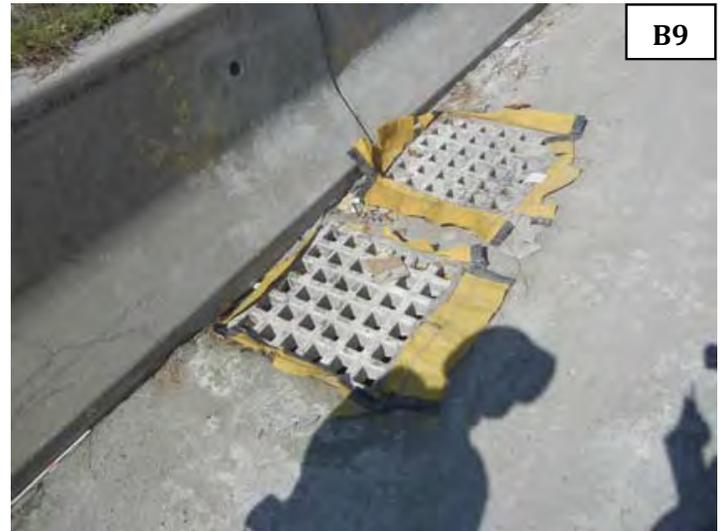
B9 - Yes, because in the picture the catch basins have protective measures installed

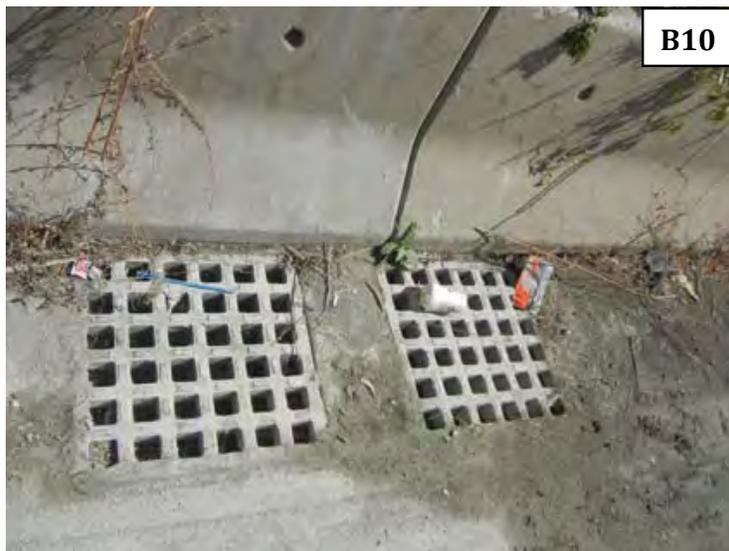
B10 - No, because in the picture there are no longer any inlet protection measure installed, so they must not have been properly maintained

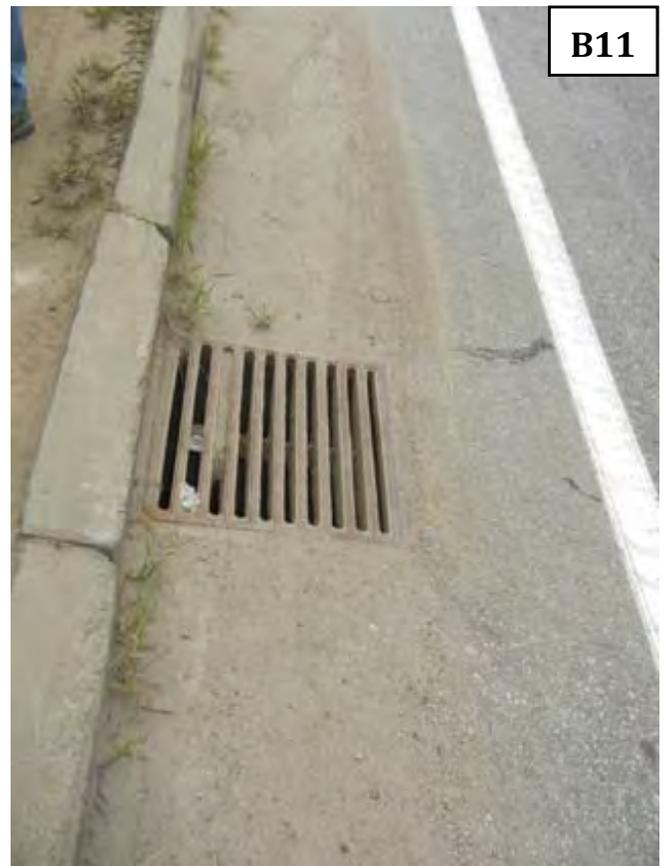
B11 - No, because in the picture there is a layer of sediment surrounding the catch basin, so cleaning of this area has not been performed within 24 hours

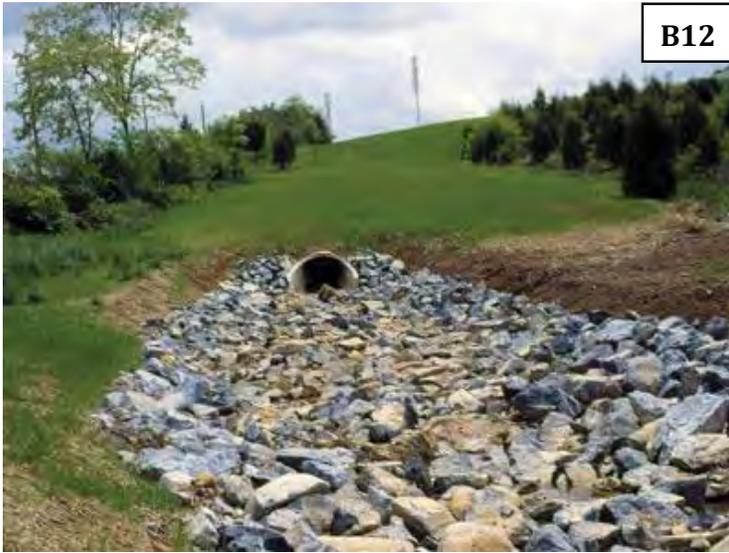
B12 - Yes, because in the picture there is an adequate layer of rip rap installed at this discharge point

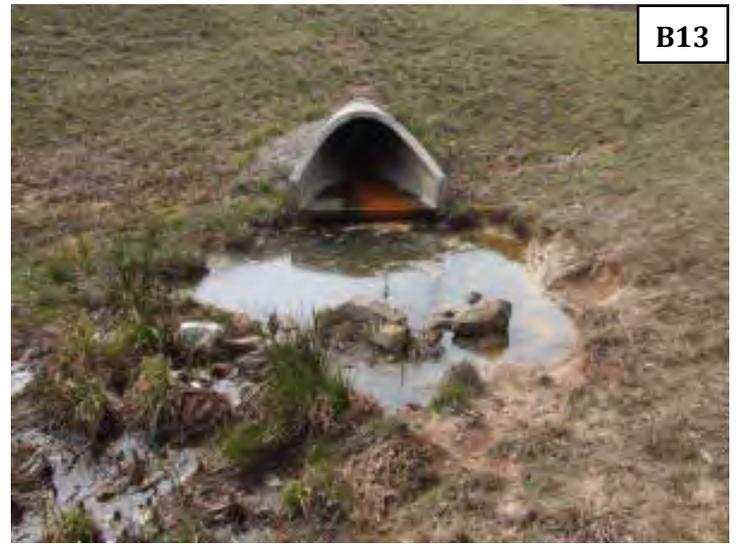
B13 - No, because in the picture there is now only a little bit of rip rap left and therefore the water is pooling in front of the outlet and no longer effectively dissipating the flow or slowing the velocity of the stormwater

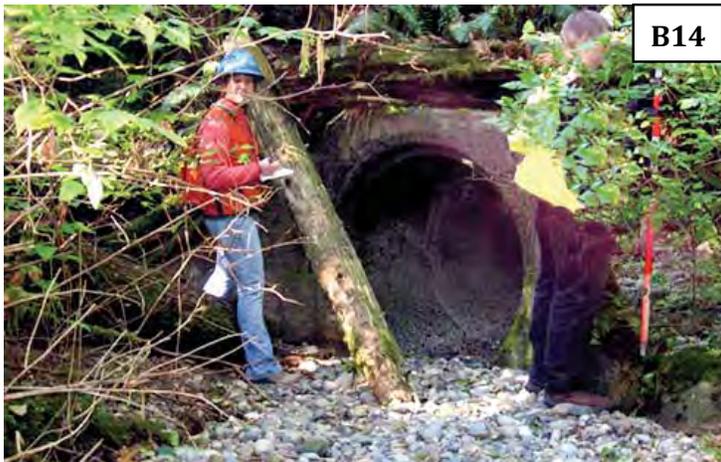
B14 (i, ii) - Yes, because in the picture the inspector is checking the outlet to make sure it was properly designed and is being well maintained

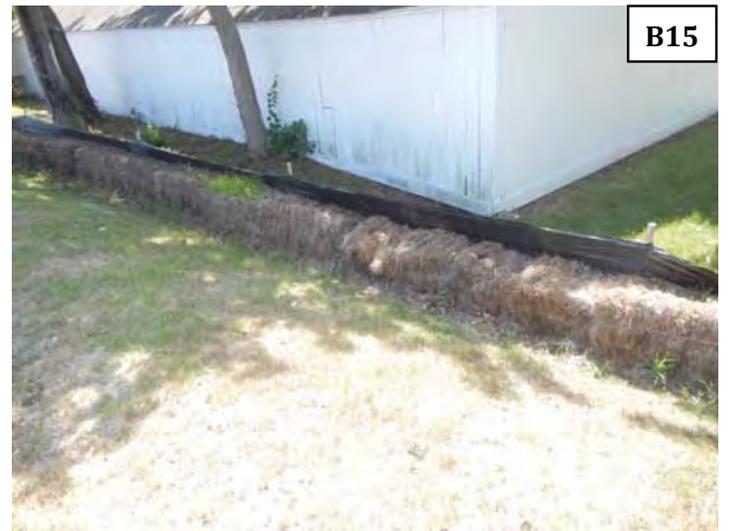
B15 - Yes, because in the picture there is a row of haybales (reinforced by a silt fence) implemented on site as a perimeter control

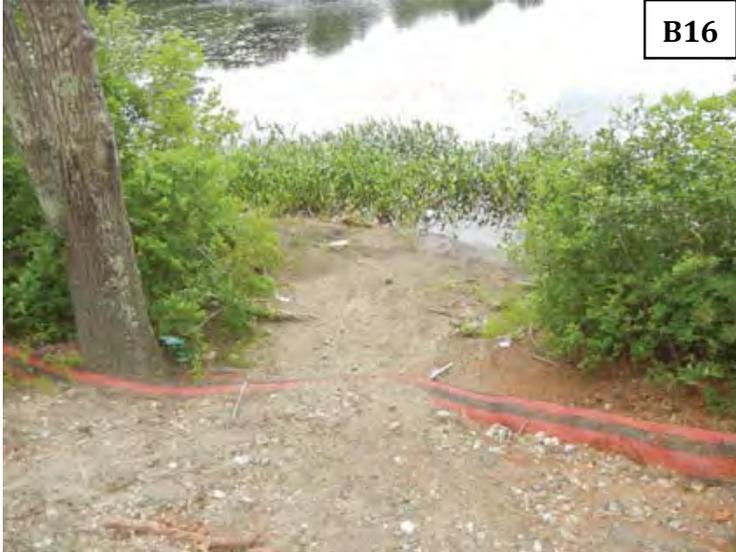
B16 - No, because in the picture the mulch sock being used as a perimeter control has been overpowered by erosion and sedimentation, which is now going directly into the lake; therefore this control was not properly maintained

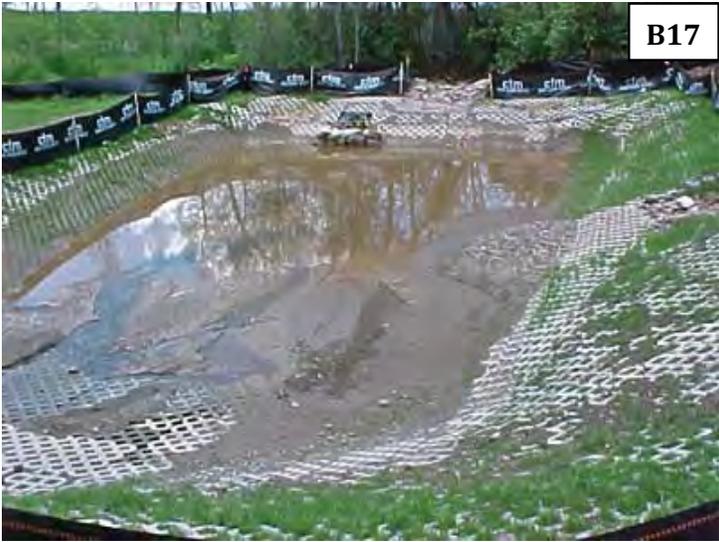
B17 - Yes, because in the picture there is a large permanent sediment basin on site that is fully surrounded by erosion controls

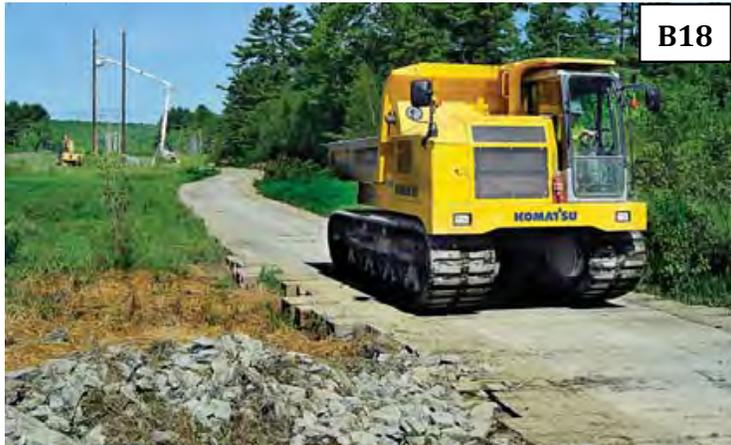
B18 - Yes, because in the picture the equipment routing is on an existing roadway, therefore construction equipment will not be able to compact any infiltration areas

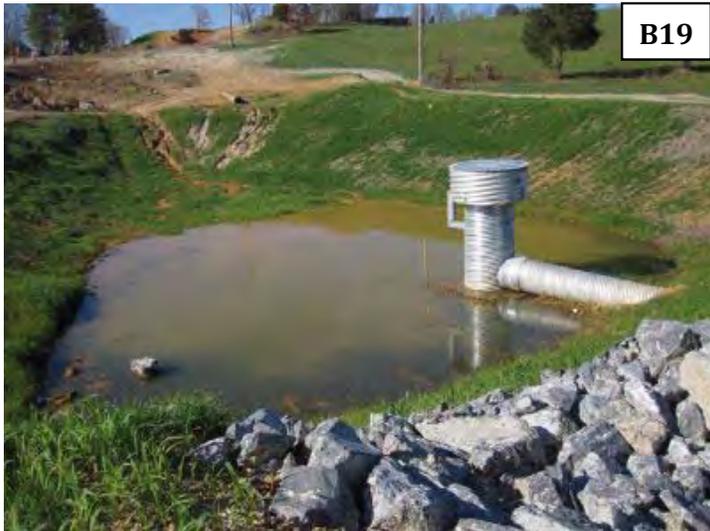
B19 - Yes, because in the picture there is a siphon installed in this temporary sediment basin

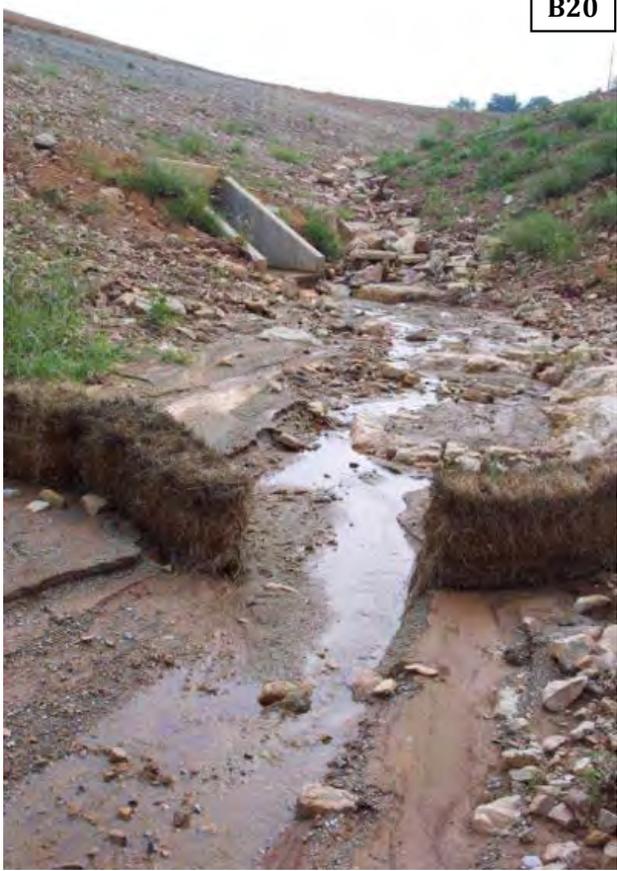
B20 - No, because in the picture the hay bales used as a temporary sediment trap have not been maintained

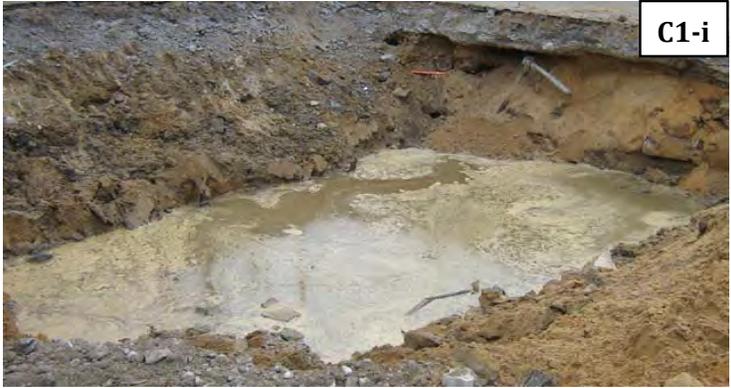
C1-i - No, because in the picture the contaminated groundwater has not been properly managed and dewatered

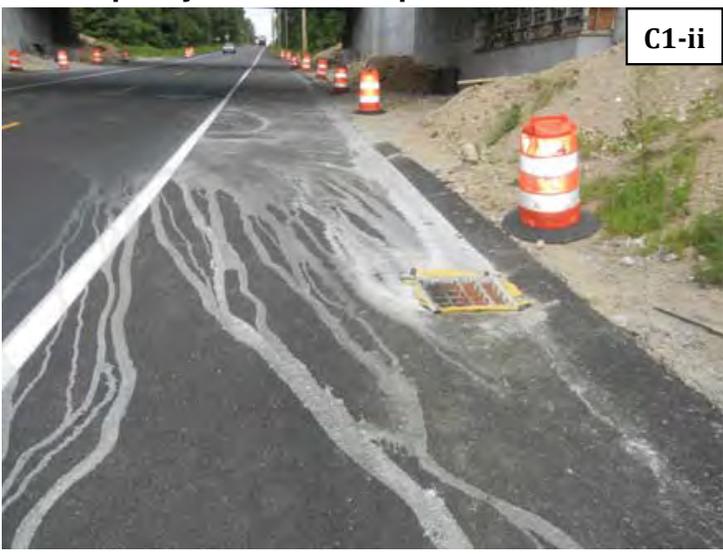
C1-ii - No, because in the picture wastewater from the washout of concrete has flowed down hill to a nearby catch basin and therefore was not properly contained or disposed of

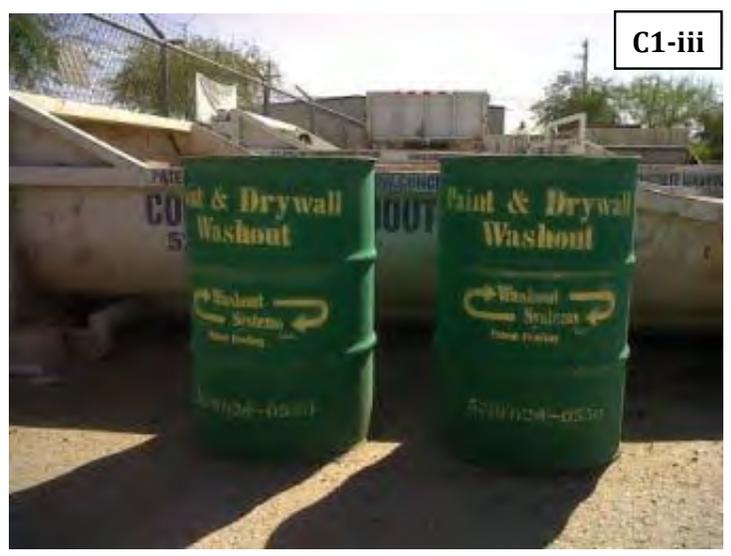
C1-iii - Yes, because in the picture there are containers on site that are specifically for the washout of paint and other construction products

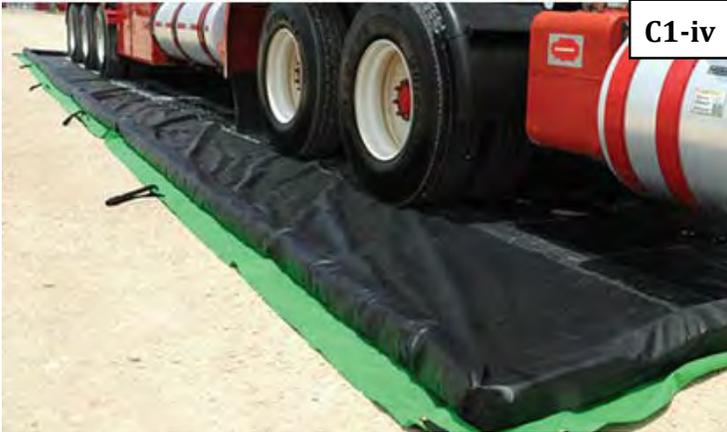
C1-iv - Yes, because in the picture there is a large spill mat being used on site to properly contain any leaks from this construction vehicle

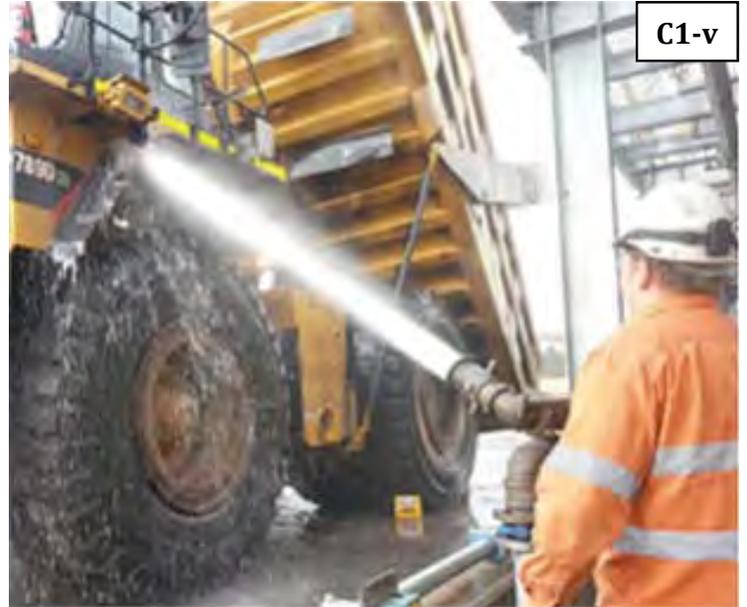
C1-v - Yes, because in the picture there are no soaps or solvents being used on the site for equipment and vehicle washing, just a high powered hose

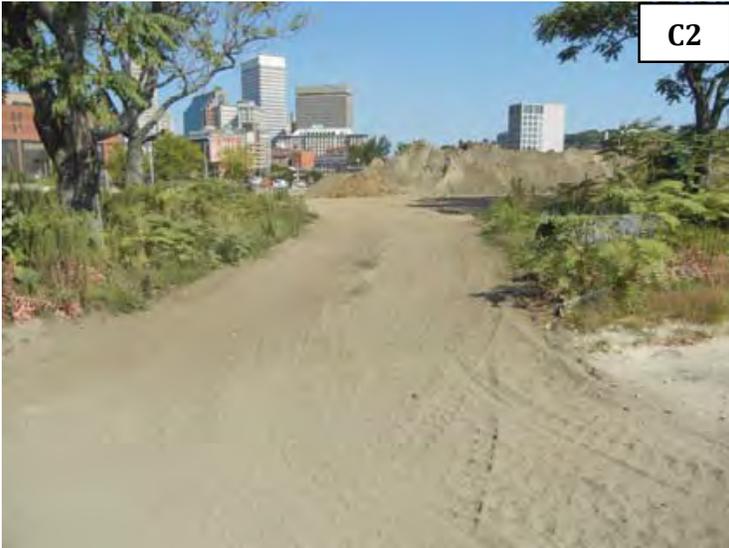
C2 - No, because in the picture it can be seen that this is not a properly designed exit point from the site, seeing as there is no crushed stone padding or other BMPs in place to remove sediment from tires before exiting

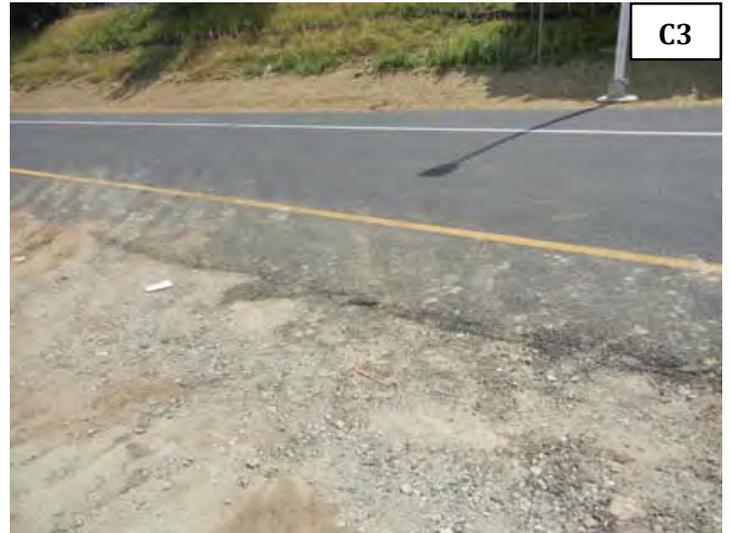
C3 - No, because in the picture there is not a crushed stone padding here, therefore the sediment is being tracked out in the active roadway from construction vehicles exiting

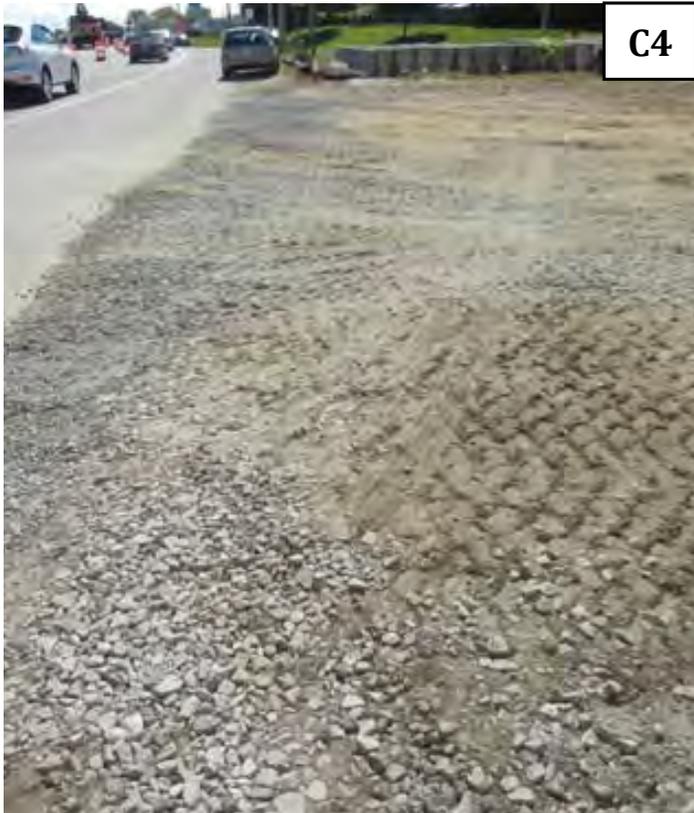
C4 - No, because in the picture there was once an adequate layer of crushed stone padding, but it has now become ineffective and there are no other controls in place to prevent sediment track out from the site

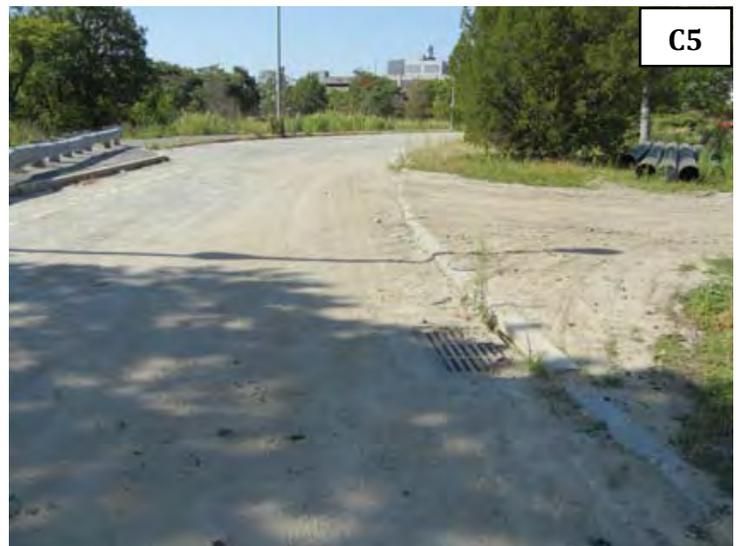
C5 - No, because in the picture there is a large amount of sediment track out that has not been removed by the end of each work day

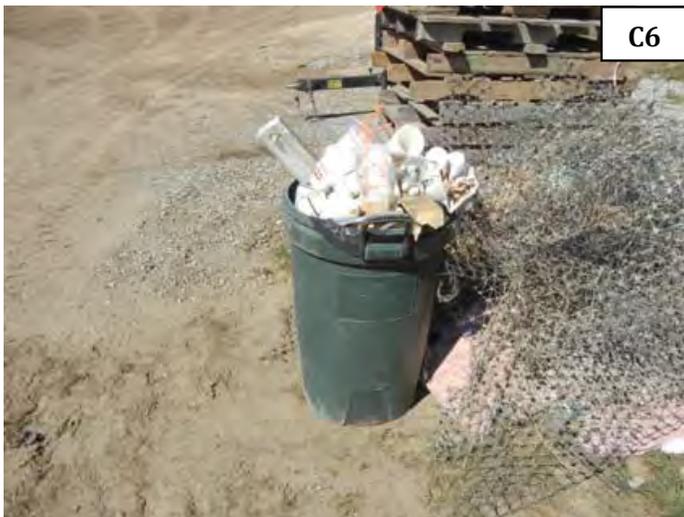
C6 - No, because in the picture there is a pile of construction debris that is not being properly contained, as well as an overflowing trash can for personal trash which also needs to be properly contained

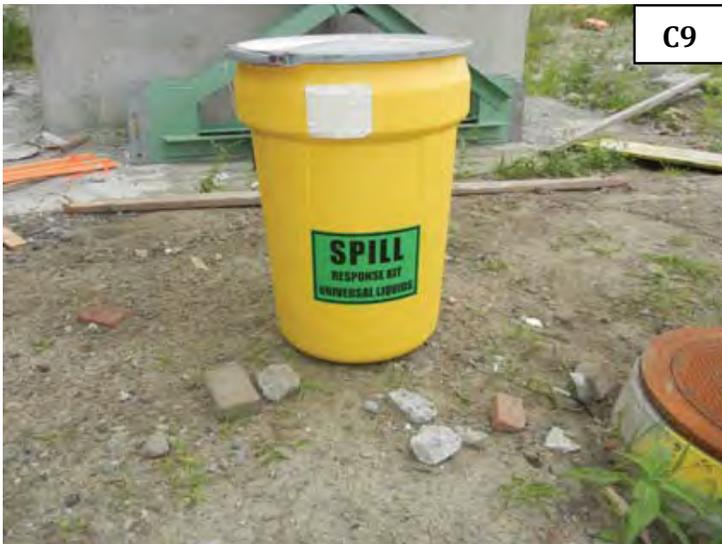
C9 - Yes, because in the picture there is a highly visible area on site for the storage of spill prevention and control equipment

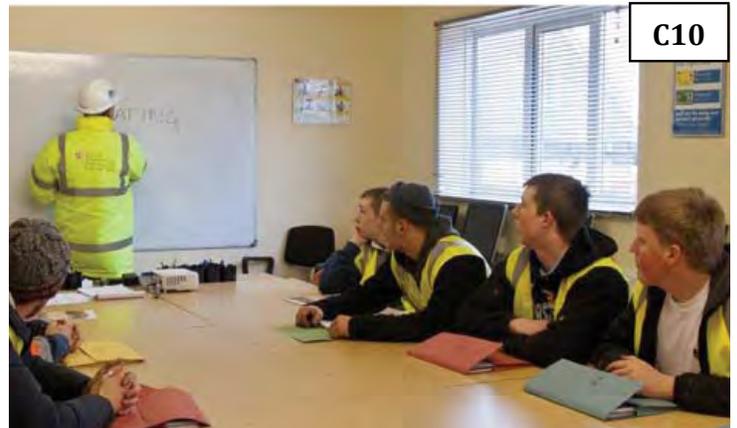
C10 - Yes, because in the picture the construction crew is being trained on how to use spill prevention and control equipment

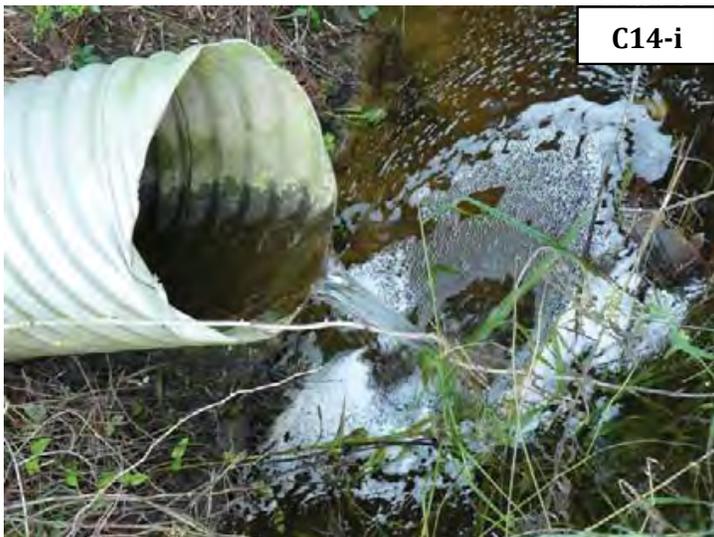
C14-i - No, because in the picture there is a discharge of foam coming from the construction site

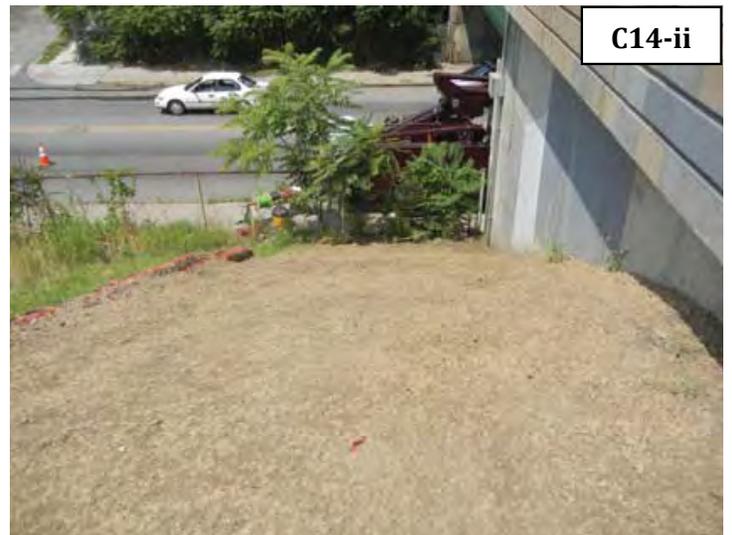
C14-ii - No, this would not be a slope to use as an infiltration area for dewatering practices

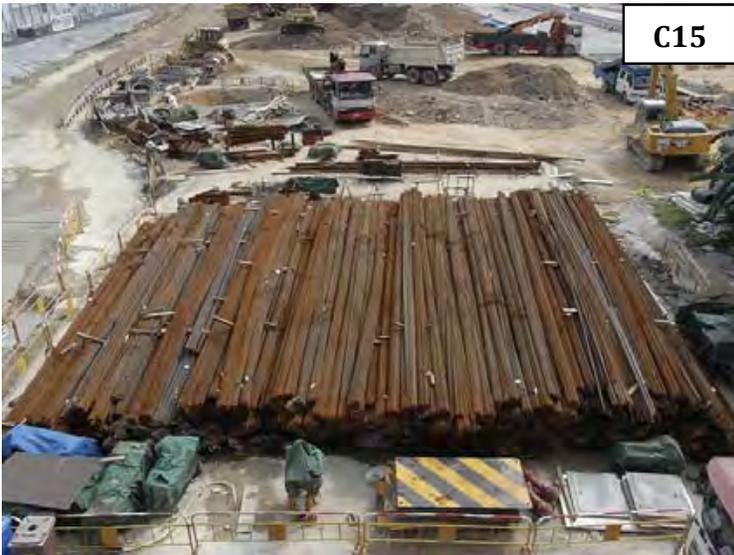
C15 - No, because in the picture there are no erosion controls surrounding the staging area

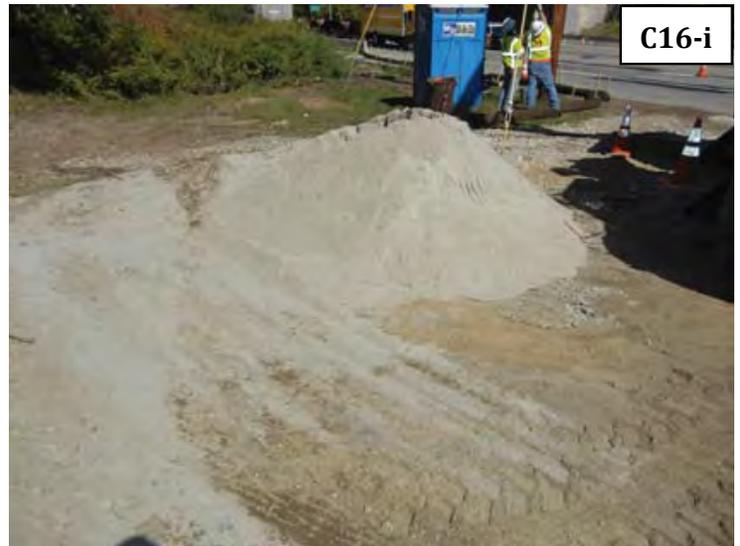
C16-i - Yes, because in the picture the stockpile is within the LOD

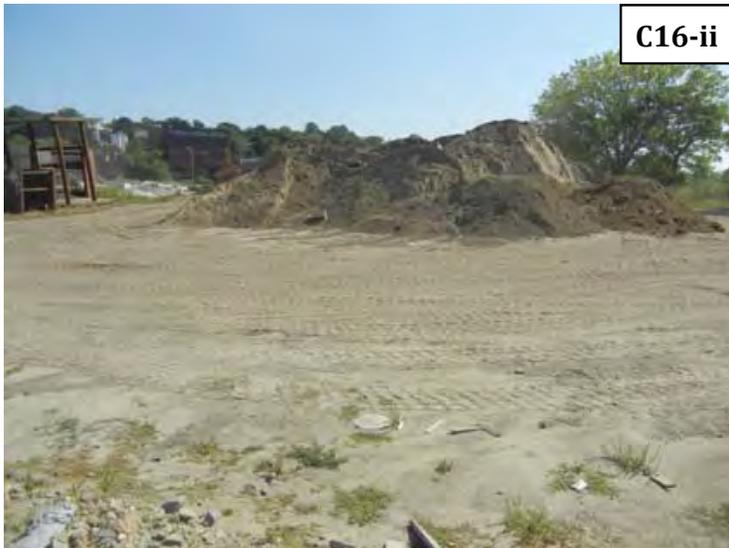
C16-ii - No, because in the picture the stockpile is neither surrounded by erosion controls nor covered with polysheeting

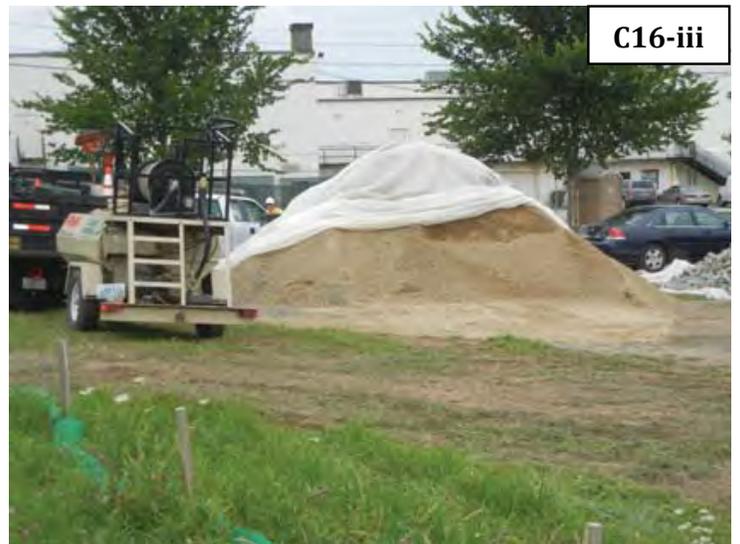
C16-iii - Yes, because in the picture the stockpile is covered with polysheeting

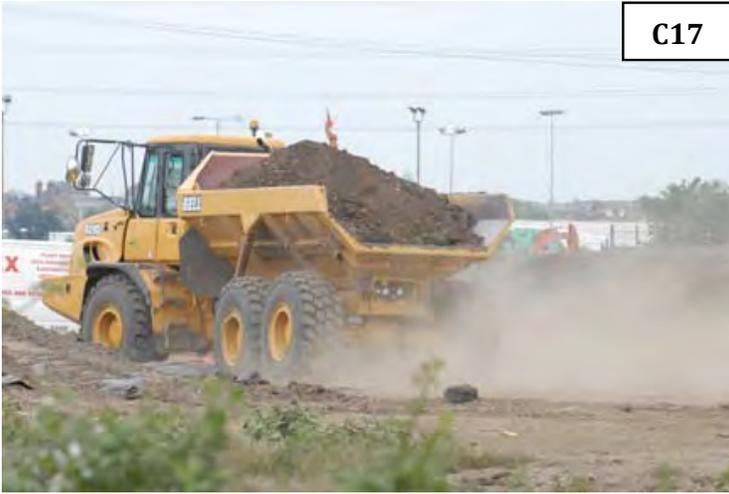
C17 - No, because in the picture there is a lot of dust being kicked up from the construction equipment, therefore it is not being properly managed through the use of water or vegetative measures

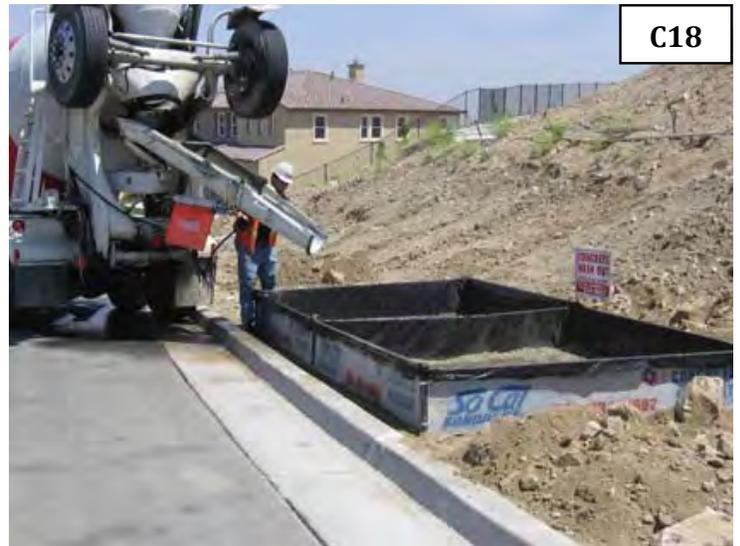
C18 - Yes, because in the picture there is a designated concrete washout area on site with a sign indicating this

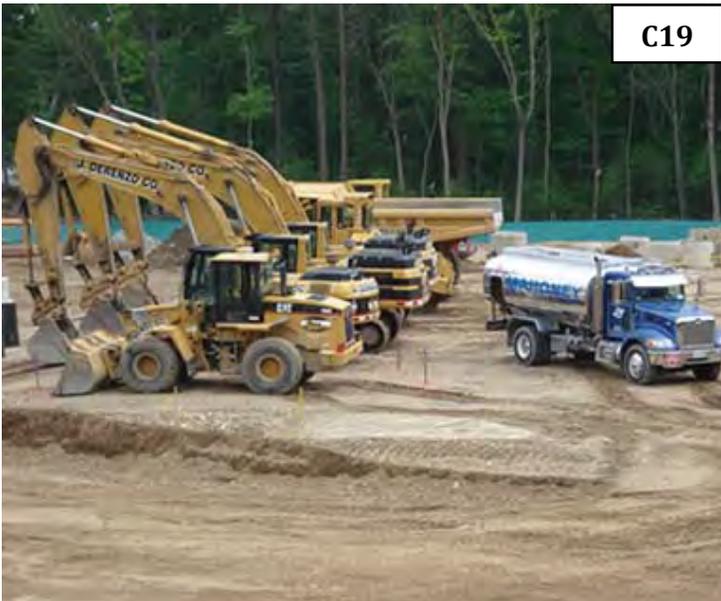
C19 - Yes, because in the picture the fuel truck is fueling all of the construction equipment in the staging area, which is surrounded by erosion controls

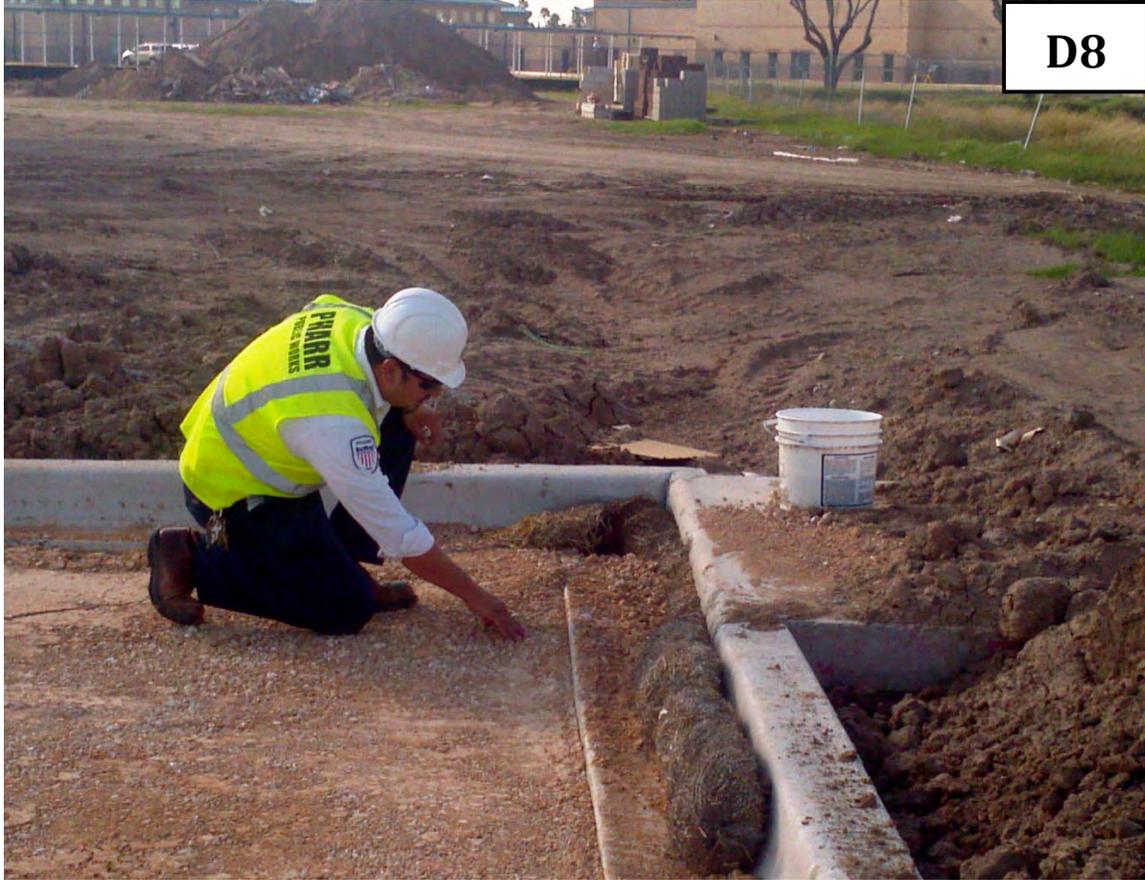
D8 - Yes, because in the picture there is an inspector performing their weekly inspection of the site

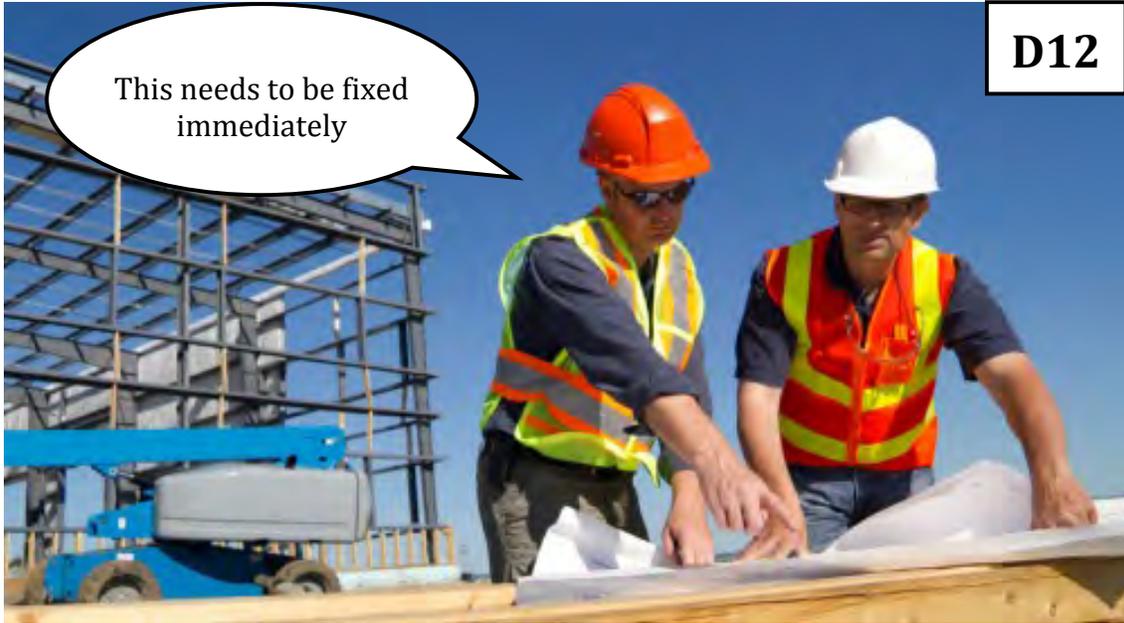
D12 - Yes, because in the picture the operator is working with his crew to fix a non-compliance issue immediately
